SciPan 4: PROGRAM DESCRIPTION AND TEST RESULTS

As part of the U.S. Department of Defense Explosives Safety Board (DDESB) Project ESKIMORE, the U.S. has conducted the fourth test in its SciPan test series, which consists of full-scale donor/acceptor trials examining debris generation and acceptor response. The SciPan 1 and 2 tests and results were reported at the 2004 DDESB Seminar. SciPan 3 was reported on at the 2006 DDESB Seminar. The overall SciPan program is described, with emphasis on the debris generation results from SciPan 4. This event, which was conducted in August 2008 at Naval Air Warfare Center, Weapons Division, China Lake, CA, was a 1,000 kg (2,205 lb) detonation of non-fragmenting munitions inside a typical reinforced concrete operating building. Results from this test including airblast effects, debris densities patterns, and fragmentation characteristics are presented. Comparisons of debris density as a function of azimuth and distance are made with analytical debris prediction models, as well as with traditional Quantity-Distance criteria.

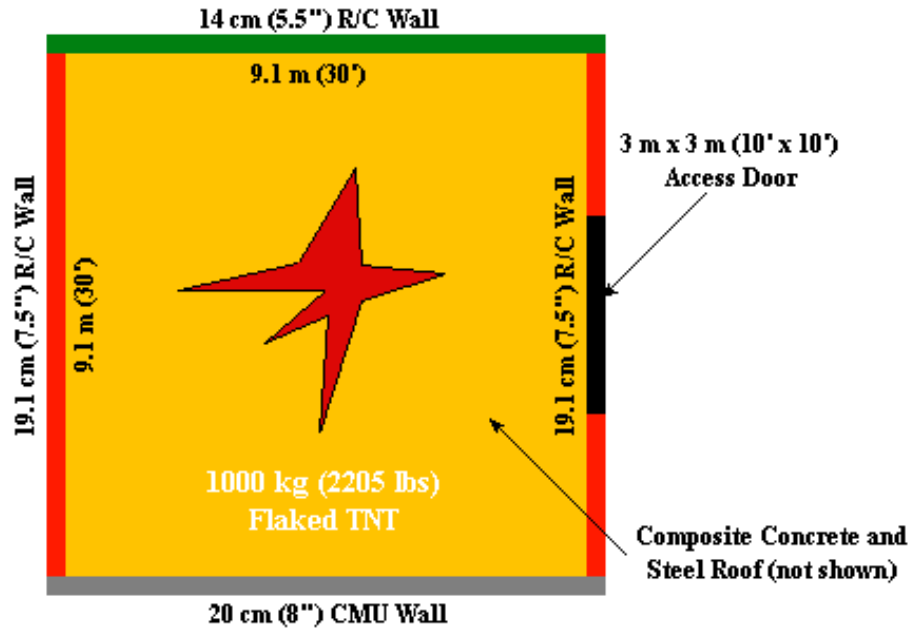
Figure 1. SciPan 4 PES Nominal Configuration

The donor building included a floor slab and foundation as well as reinforced concrete and masonry walls and a composite reinforced concrete/steel panel roof. The PES was designed for normal dead plus live loads (NB: The PES was not a hardened structure). The PES dimensions and building materials were chosen to represent those of a typical operating building. The building was 9.1m by 9.1m (30' by 30') in floor plan with a ceiling height of 3.05m (10'). A 3.05m by 3.05m (10' x 10') opening was provided in one of the 19 cm RC walls for access during construction and test setup. Figure 1 shows the nominal PES configuration.

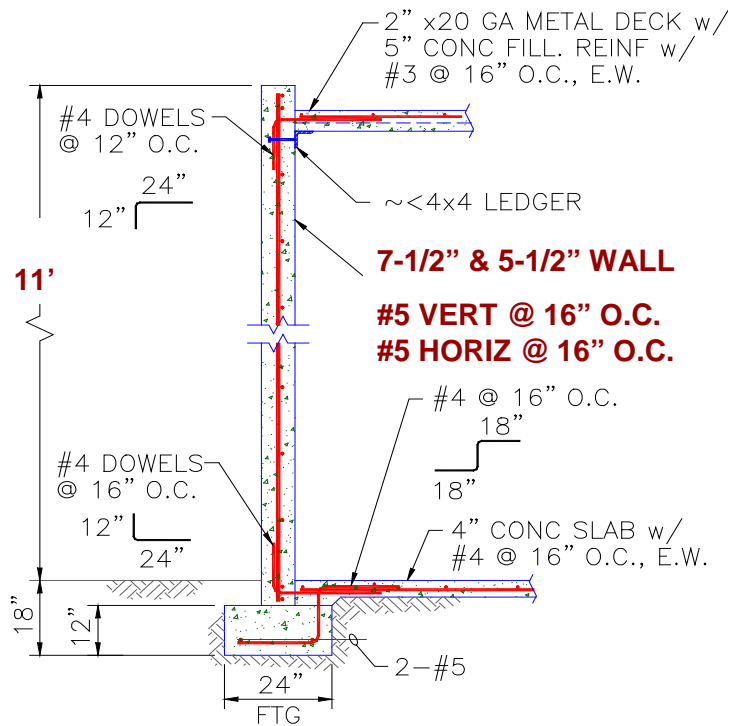
Figure 2A. PES R/C Wall Cross-Sections

The walls were significantly different in cross-section, but typical of normal construction practices. Two walls were 7.5" R/C with No. 15 rebar @ 40 cm (#5 @ 16") centers each way. The third wall was 5.5" R/C with No. 15 rebar @ 40 cm (#5 @ 16") centers each way. The fourth wall was constructed from fully-grouted, 8" CMU with No. 15 rebar vertical @ 40 cm (#5 rebar @ 16") centers and No. 15 rebar horizontal @ 80 cm (#5 @ 32") centers. Each wall was constructed such that it would remain independent, i.e., the walls were not tied together at the corners. This was done in an attempt to isolate the response of the different wall types. Figures 2A and 2B show cross-sections through each of the walls.

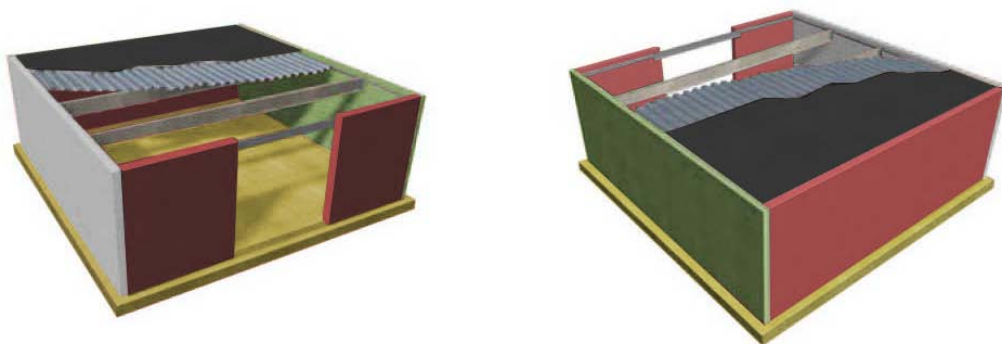
Figure 3. SciPan 4 PES (Computer Generated)

To ease identification of the sources of the debris, colored pigments were included with the various concretes. Figure 3 shows computer-generated images of the PES structure and the pigment color scheme in the concrete. Figure 4 shows the actual PES structure.

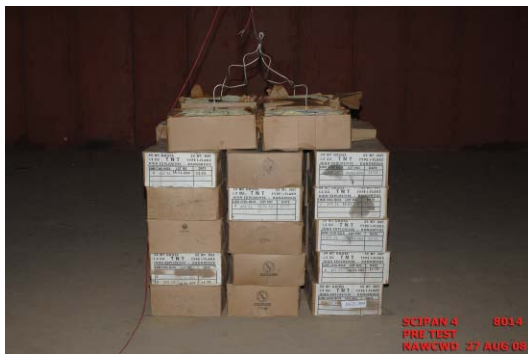
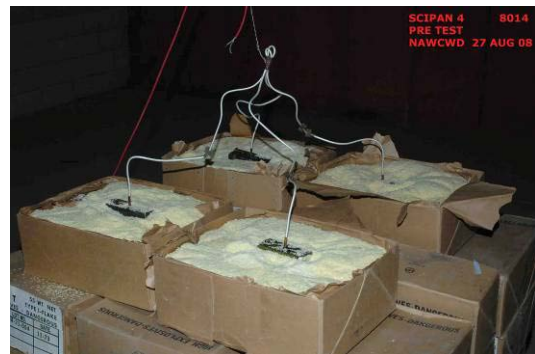
Figure 5. Charge Arrangement and Initiation Setup

The donor charge was composed of flaked TNT contained in fiberboard boxes, with each box weighing approximately 25 kg. 40 boxes were used to achieve the nominal NEQ of 1000 kg. The charge was stacked as a rectangular parallelepiped located in the center of the PES, carefully placed such that it was equidistant from the walls. Four blocks of C-4 were used as a booster in conjunction with four 50-cm lengths of detonating cord to ensure complete detonation of the TNT. Figure 5 depicts this setup of the donor charge and the initiation system.

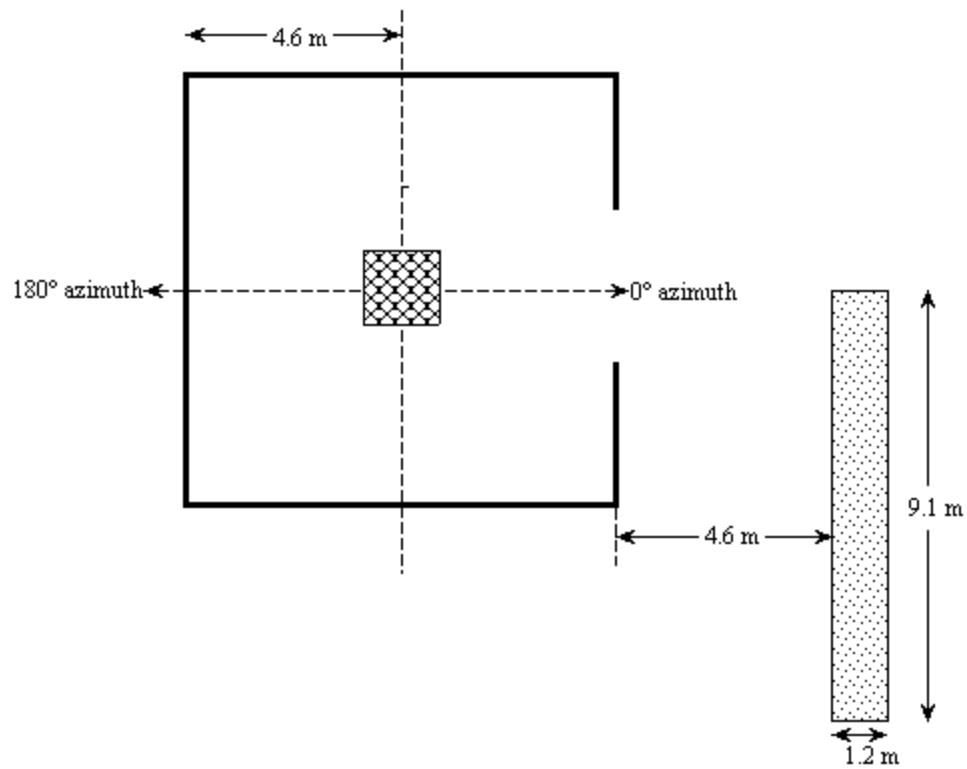
Figure 6. HESCO Bastion Barricade Schematic

A sand-filled HESCO Bastion barricade was constructed 4.6 meters in front of one half of the door side of the PES. Figure 6 shows the barricade location while Figure 7 shows photographs of the completed barricade.

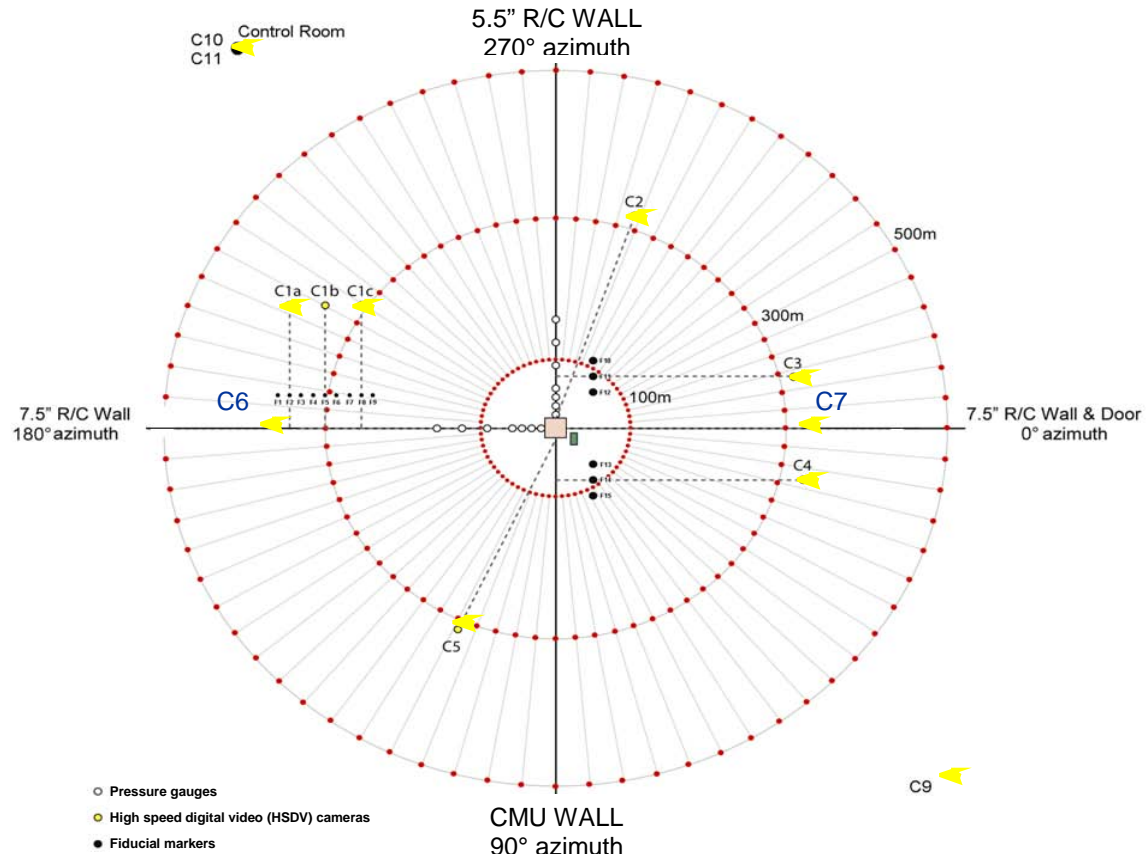
Figure 8. SciPan 4 Instrumentation Layout

Incident airblast was measured along two radial lines extending from the center of the PES out along the 180° and 270° azimuths, as shown in Figure 8. Pressure transducers were placed at the following nominal distances from the center of the PES:

The debris recovery grid was marked out in $5^\circ \times 200$ m sectors, starting at 100 m and going out to 500 m. The sectors were marked out over the entire 360° domain and the origin of the recovery grid was the center of the PES. As shown in Figure 8, the normal to the 7.5\" R/C wall and door side is the 0° reference azimuth, with the normal to the full 7.5\" wall in the 180° direction. The normal to the CMU wall is the 90° direction, while the normal to the 5.5\" R/C wall is the 270° direction. Markers were placed at each intersection of radial distance with azimuthal angle for reference during the collection and cataloguing process. These markers are represented by the red dots in Figure 8.

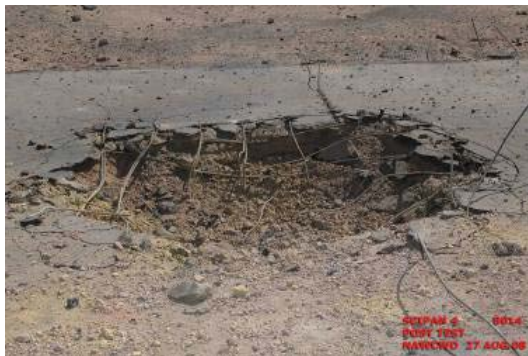
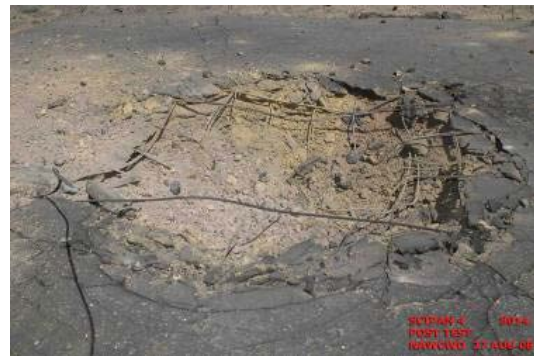
Figure 9. SciPan 4 Crater

The crater formed by the event was far smaller than those seen in previous SciPan tests. The approximate diameter of the crater varied between 2.5 and 3.0 meters. The maximum depth of the crater was approximately 0.65 meters. Figure 9 shows two views of the crater.

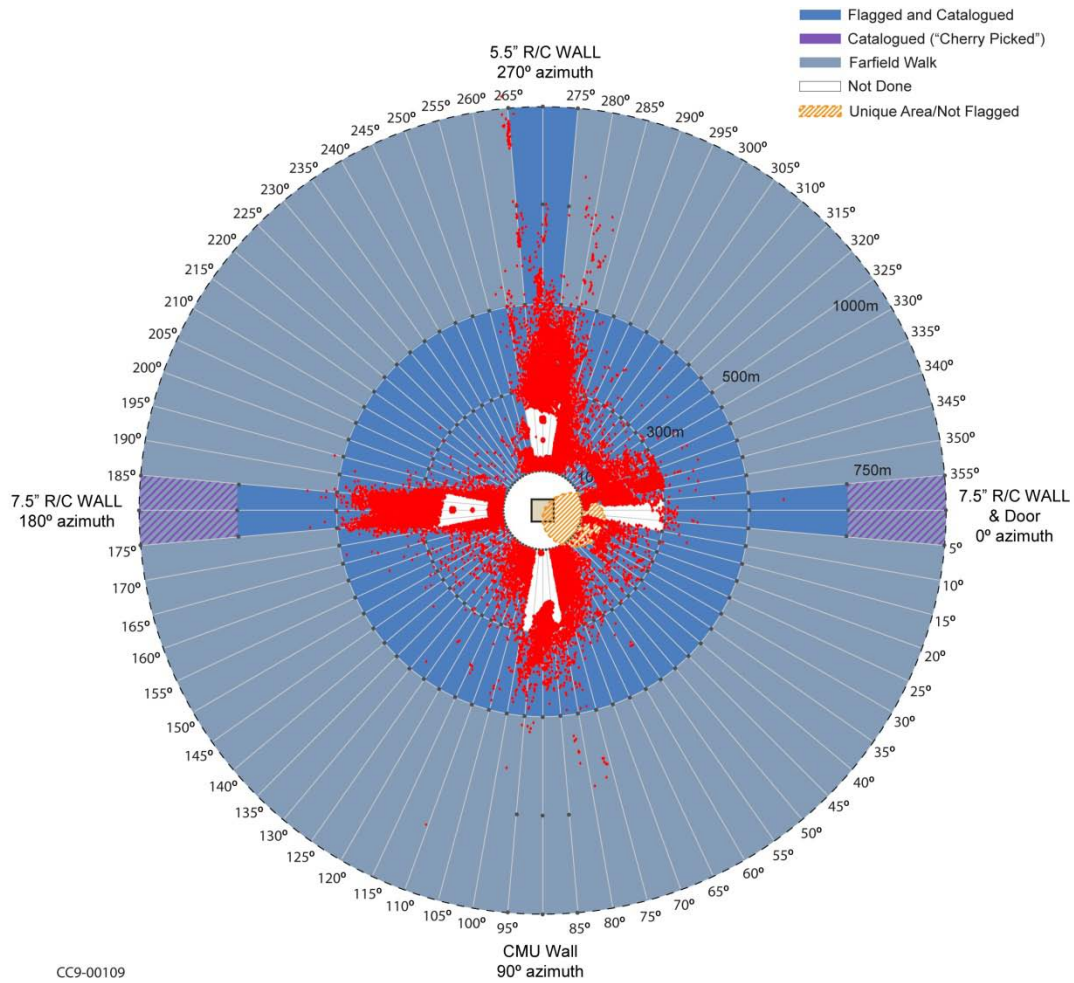
Figure 10. SciPan 4 Debris Scatter Plot

The normals were completely saturated with debris from 100 to 300 meters, and it proved inefficient to focus debris collection efforts there. Though the sectors within $\pm 10^\circ$ of each normal were not rigorously searched out to 300 meters, complete recovery efforts were conducted in strategic areas inside these normals to aid debris characterization of these areas.

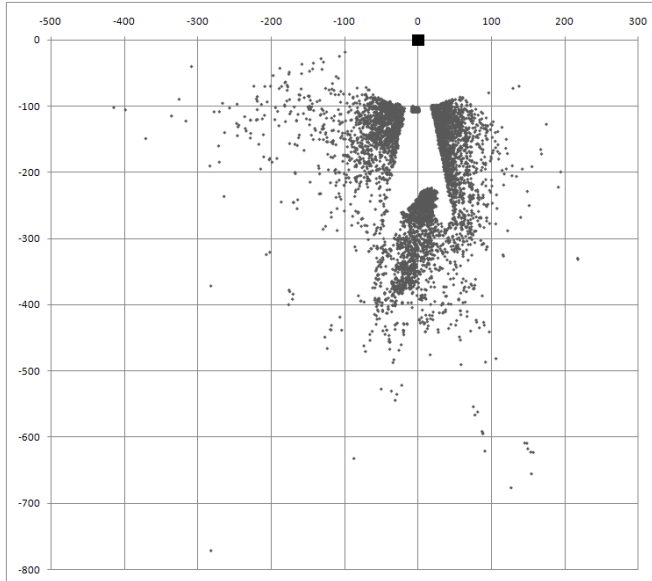
Figure 11A. CMU Wall Debris

Figures 11A through 11C show the debris pattern for a given wall type. All dimensions for these plots are in meters. Note that only concrete debris is included in all of the following data analyses, figures, and tables presented in this paper. Steel and other miscellaneous debris will not be discussed herein. (NB: The discussions of CMU wall debris hereafter shall consider both the CMU block and CMU grout in discussion of generated wall debris.)

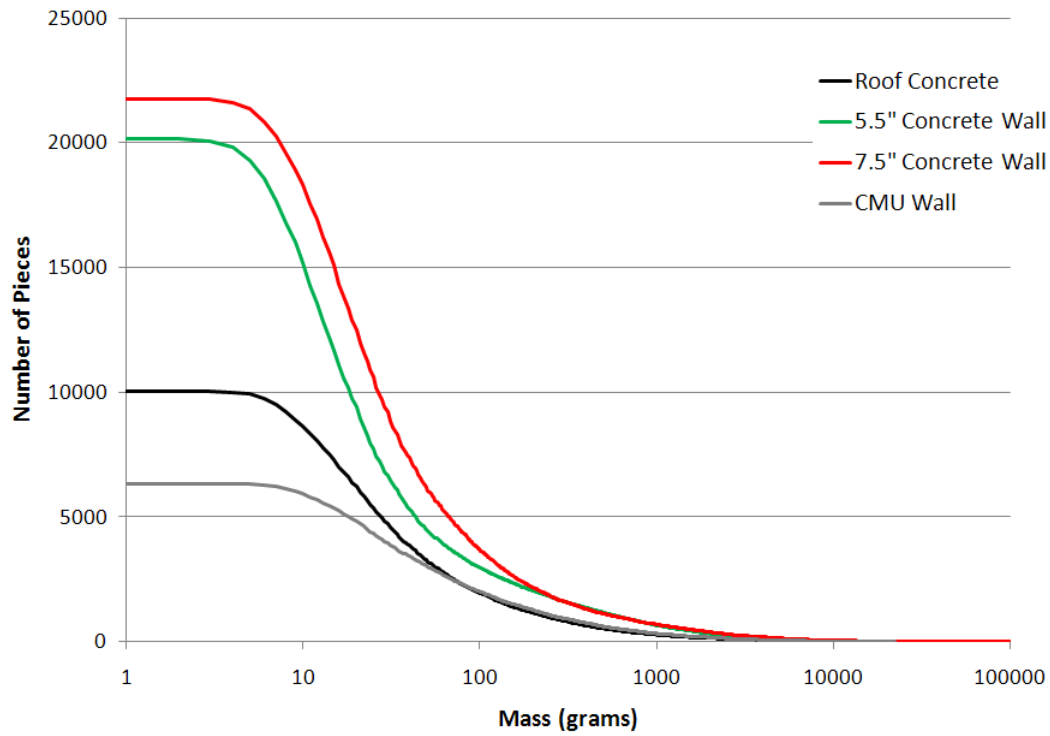
Figure 12. Cumulative Mass Distribution for Components of SciPan 4

Expanding from the Mass Bin format, Figure 12 shows the cumulative mass distributions for the individual structure components tabulated in Table 5. The plots are shown to plateau for values less than 10 grams, but it should be kept in mind that debris less than 9 grams was not targeted in the collection effort. Debris was collected that weighed less than the threshold, but in all likelihood the actual cumulative mass distribution for this test continues to rise as the horizontal axis approaches 1 gram.

The amplitude of the curves in Figure 12 is directly proportional to the total number of pieces collected for a given component. There was approximately twice as much 5.5” R/C debris collected as there was CMU debris, so a direct comparison of their respective mass distributions becomes difficult. Perhaps a better way to compare the break-up of the various components of the SciPan 4 donor structure is to normalize the cumulative mass distributions by dividing each curve by its corresponding total number of pieces collected. Figure 13 shows this comparison, and allows for qualitative comparisons between the components. It can be asserted that the 5.5” R/C wall was broken into a higher fraction of small pieces than the other components. Conversely, it appears that the CMU wall had a tendency to break into larger pieces than that of any other component.

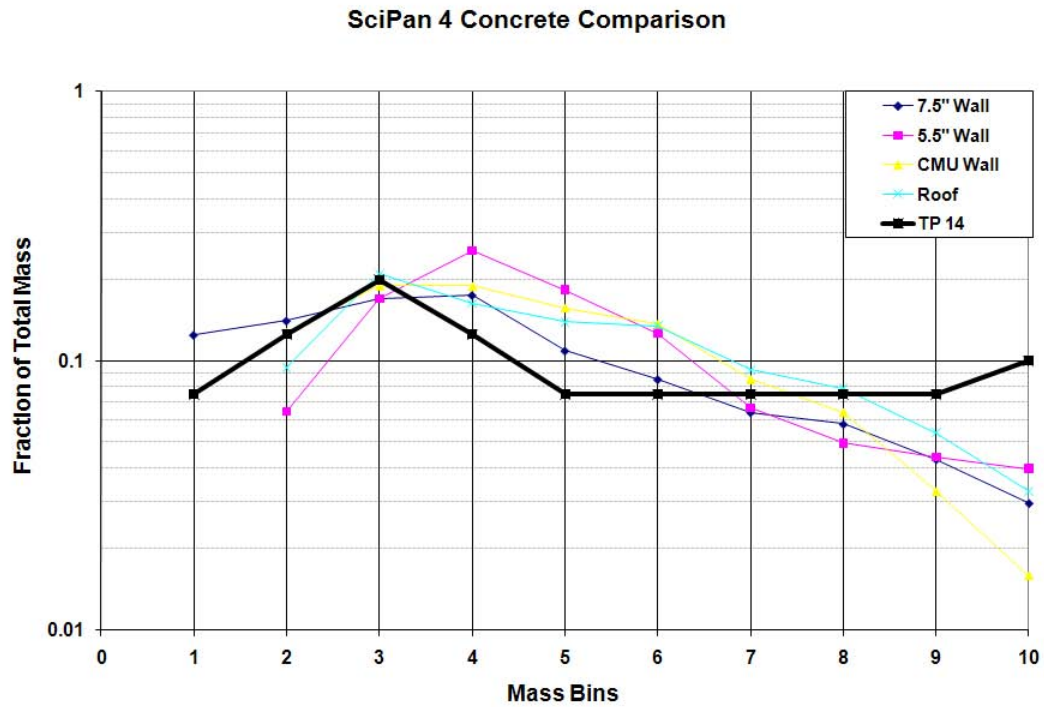
Figure 14. Fraction of Total Mass Comparison per Mass Bin for SciPan 4

The values presented in Tables 6 and 7 are plotted graphically in Figures 14 and 15. As can be seen in the figures, the mass distributions of the roof and three wall components all trend in a similar manner.

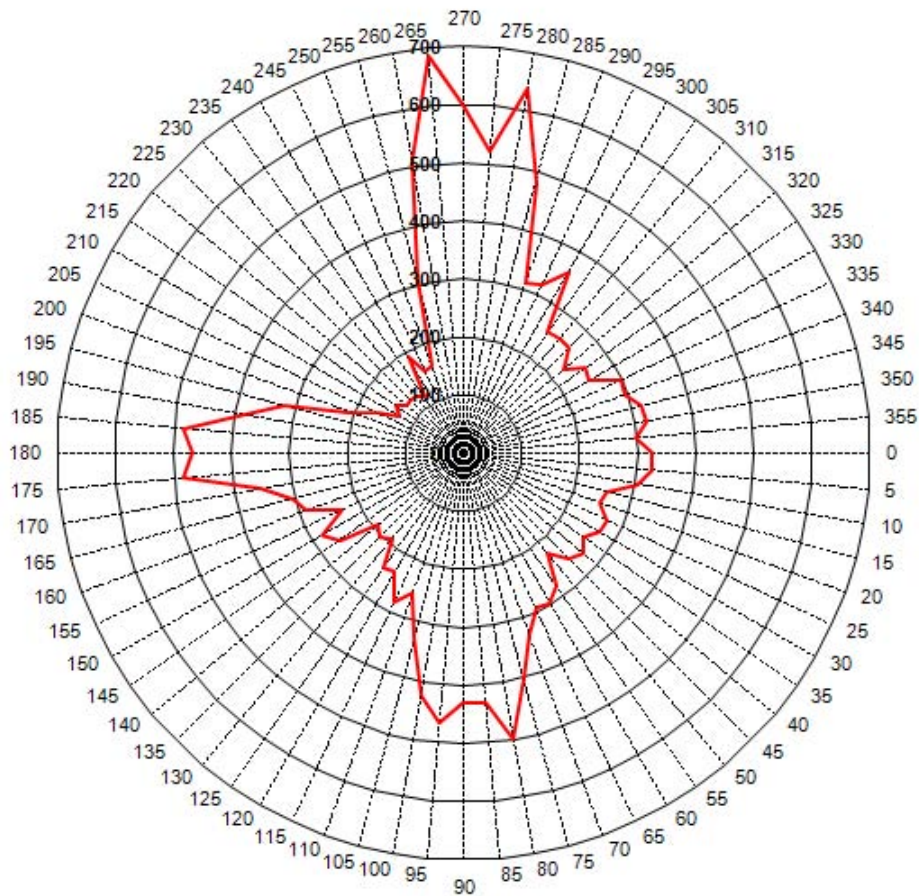
Figure 16. SciPan 4 PTN Debris IBD

- 0° direction, 7.5" R/C Wall and Door – 325 meters @ 5°
- 90° direction, CMU Wall – 500 meters @ 80°
- 180° direction, 7.5" R/C Wall – 486 meters @ 185°
- 270° direction, 5.5" R/C Wall – 686 meters @ 265°

The direct correlation in azimuthal sector between maximum debris range and maximum debris IBD for a given direction can be noticed.

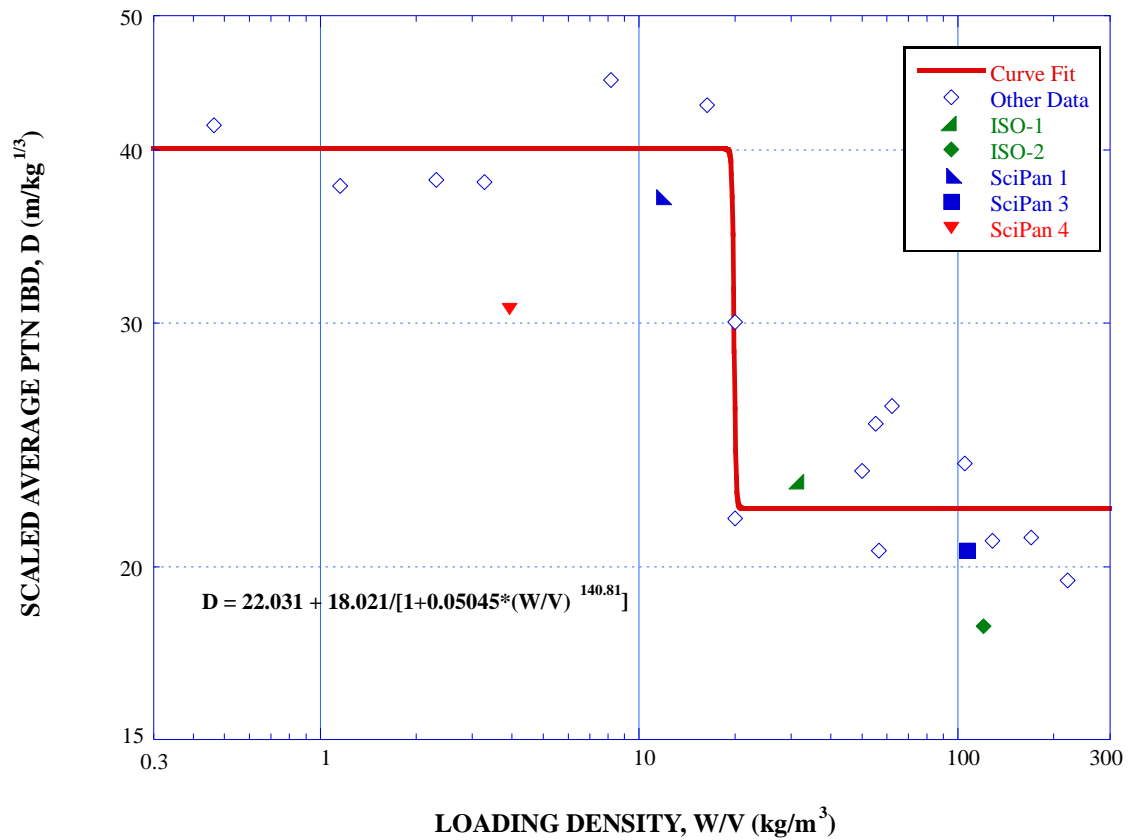
Figure 17. Scaled PTN Debris IBD Chart

When the SciPan 4 debris data are averaged over the full 360° of azimuth, a PTN debris IBD of 307 meters is obtained. It has been shown that the cube root of the PTN debris IBD has a high correlation to the loading density of the structure¹⁰. This relationship is presented in Figure 17 with the data point for SciPan 4.

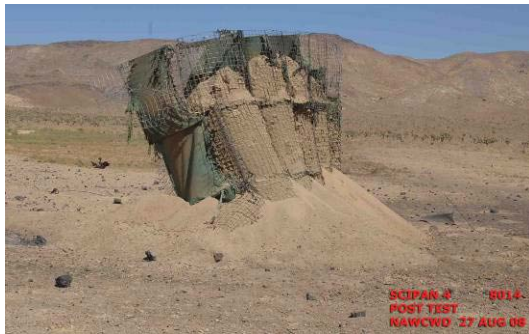
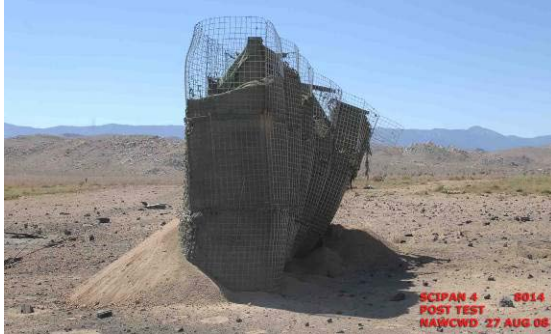
Figure 18. Barricade Results Post-Test

Figure 18 shows the barricade after the detonation. The portion of the barricade that was directly normal to the 7.5" wall was completely obliterated, while the rest of the barricade remained standing, albeit after sustaining massive damage.

A general observation made of the debris field was that there were multiple very large pieces of concrete debris from the 7.5" R/C wall within 100 meters on the barricaded side of the wall. Conversely, neither the un-barricaded side of the 7.5" R/C wall on the 0° azimuth nor the 7.5" R/C wall on the 180° azimuth were characterized in this manner. Furthermore, upon examination of the high-speed video data, several large pieces of concrete debris from the 7.5" R/C wall on the 180° azimuth were seen traversing the field of view, but those large pieces of concrete debris were not found during the debris recovery process.

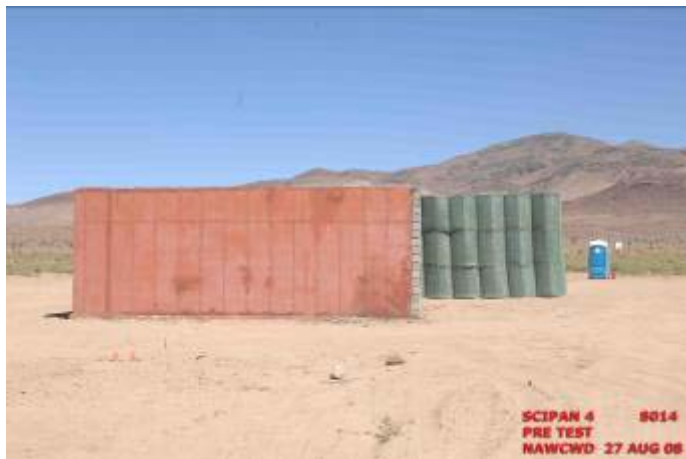
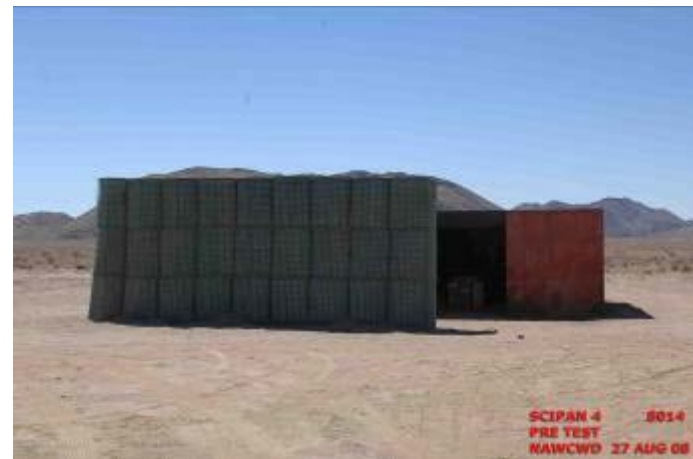
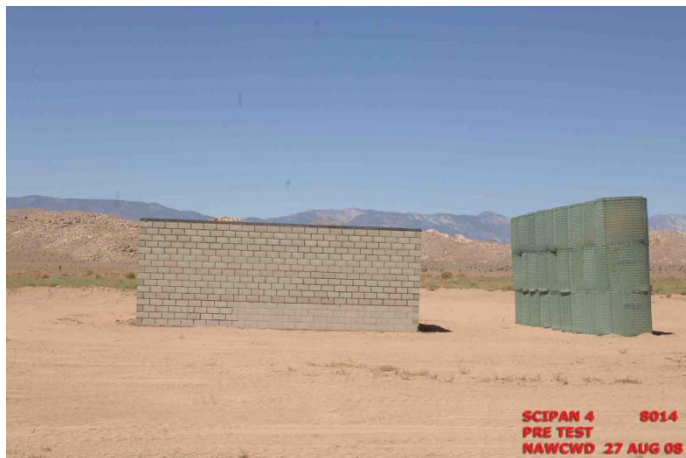
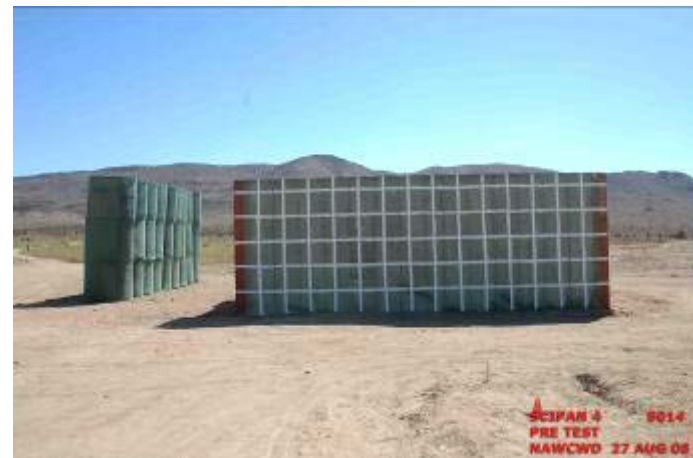
Pre-Test PES Views

- Potential Explosion Site (PES) was designed as a typical reinforced concrete (R/C) and reinforced masonry operating building
- NEW = 1,000 kg (2,205 lbs) of flaked TNT in the center of the structure
- Loading density = 3.92 kg/m^3 (0.244 lbs/ft³)
- Composite roof (concrete on steel deck) and three different wall types:
 - 19 cm (7.5") R/C
 - 14 cm (5.5") R/C
 - 20 cm (8") reinforced Concrete Masonry Unit (CMU)
 - R/C roof over corrugated metal panel
- ES structures
 - None
- Planned Debris Collection
 - 360° recovery outside 100 m from Ground Zero
- Test conducted at NAWC-WPNS, China Lake
 - Test detonated on 27 August 2008
 - Debris cataloging began immediately after shot and ended 6 September
 - A follow-on recovery effort (DIRT 4.1) took place 15 – 20 December 2008
 - Another follow-on recover effort (DIRT 4.2) took place 14 – 19 September 2009

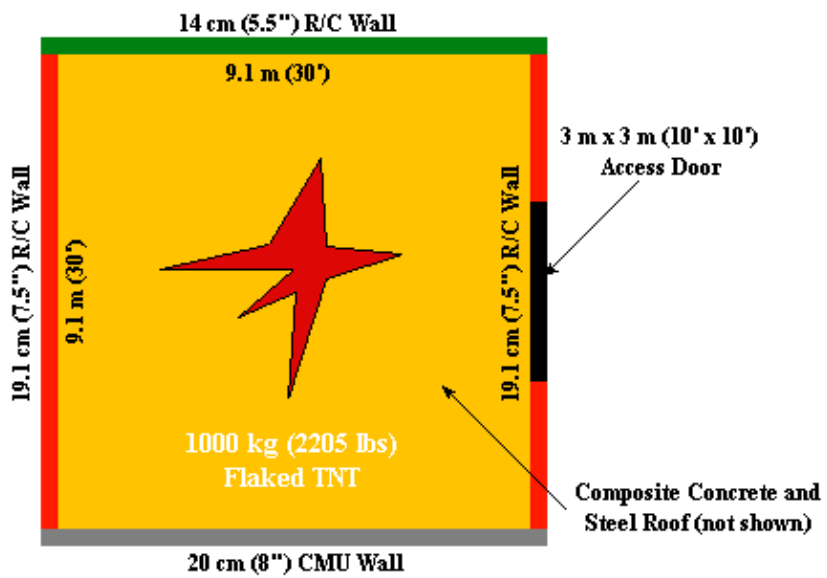
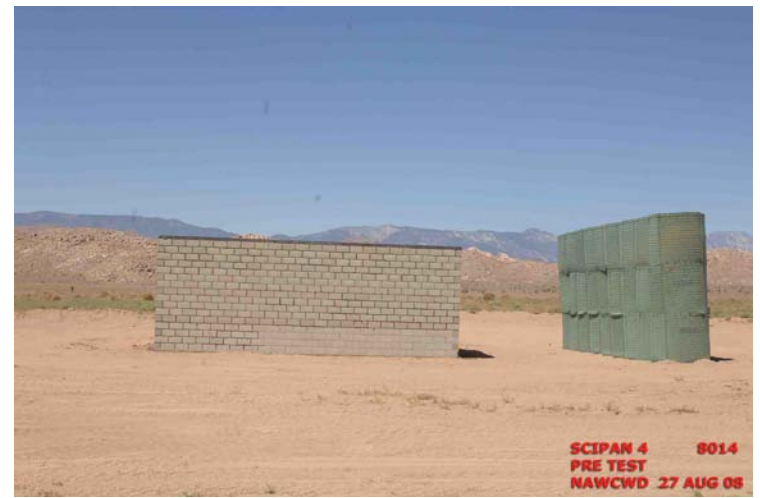
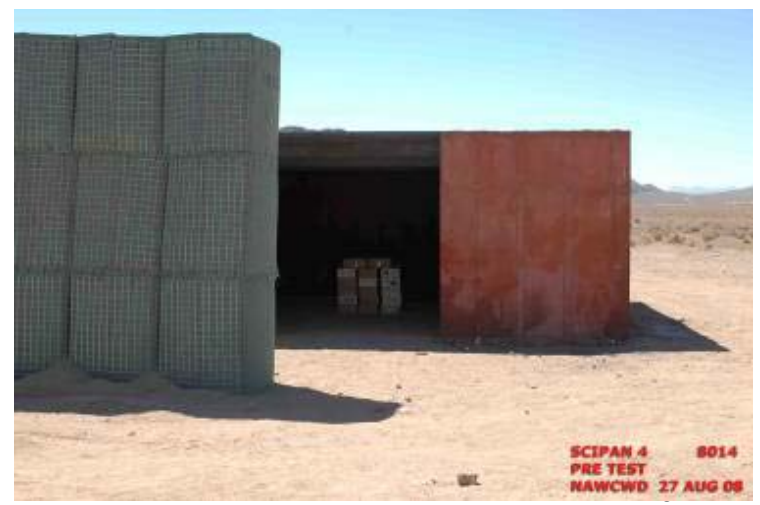
Barricade

- Quantify the attenuation to the blast wave caused by the interaction with the PES.
- Determine the effects of a HESCO Bastion barricade on the debris distribution
- Observe the interaction of the blast wave/debris field with a vertical face barricade

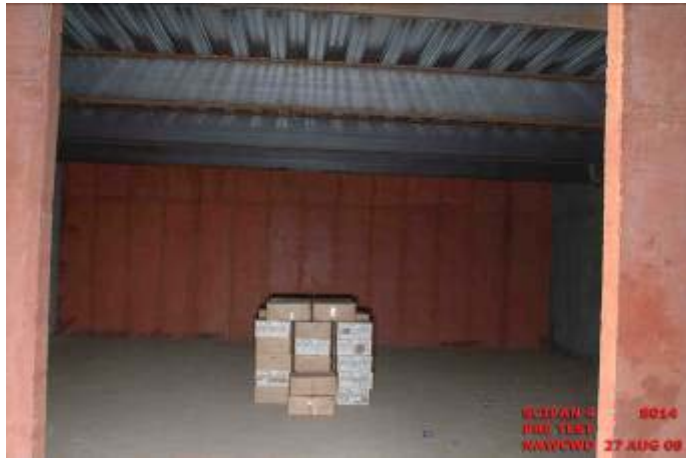
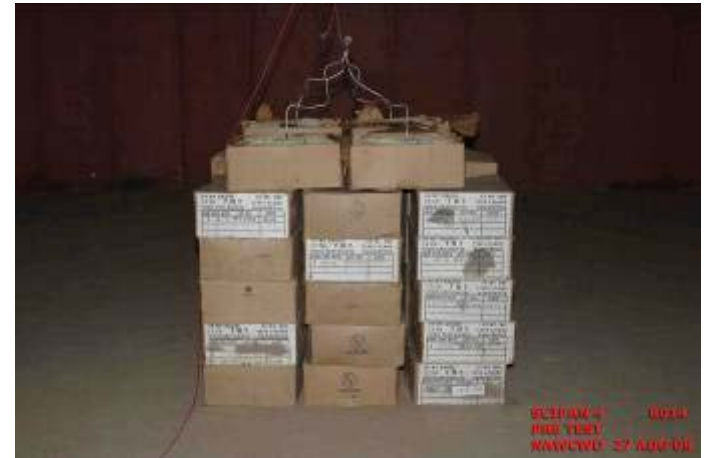
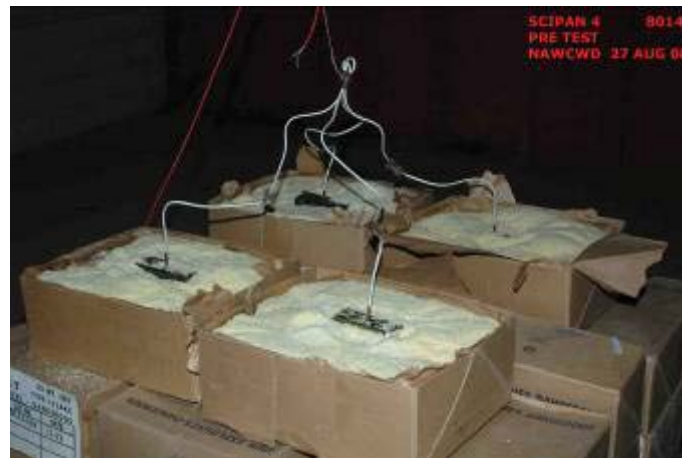
Donor Charge

1,000 kg Flaked TNT

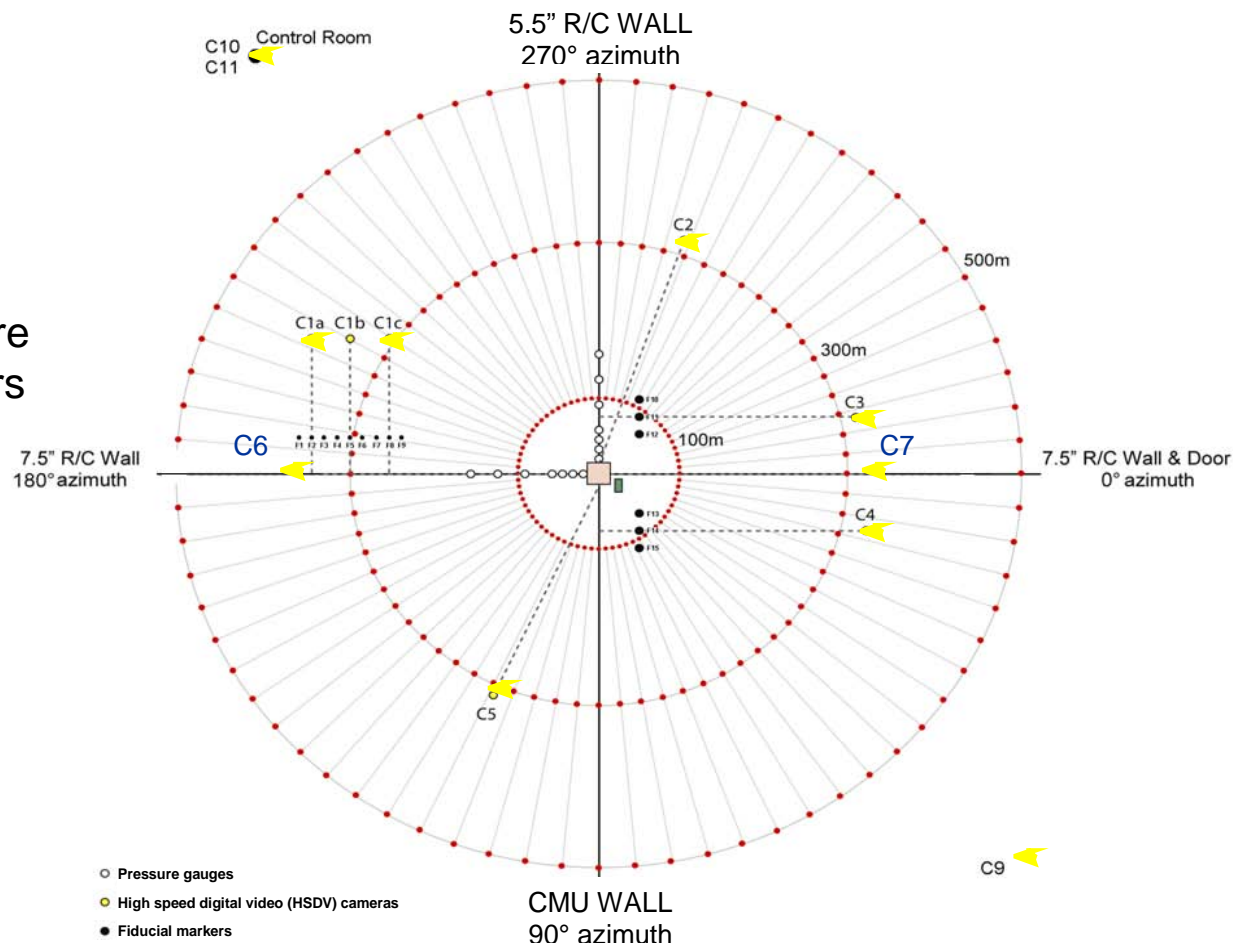
- Multiple high-speed and normal speed cameras for video coverage
- Two radials of pressure gauges from 15 meters to 150 meters
- Debris recovery grid marked out in 5° sectors at 100, 300, and 500 meters

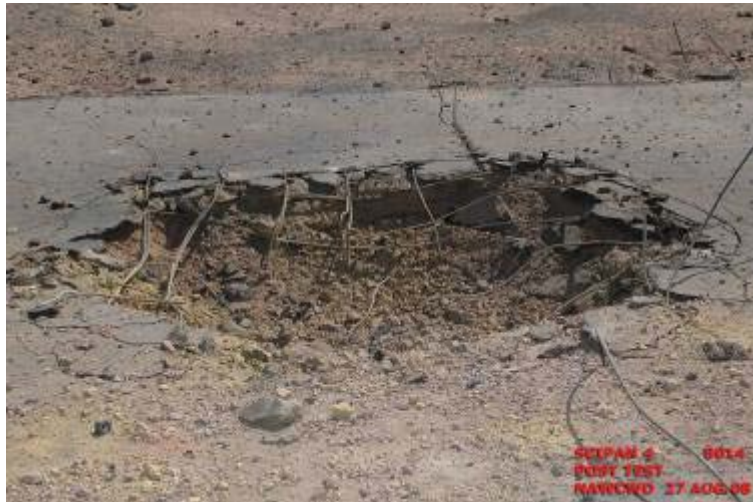
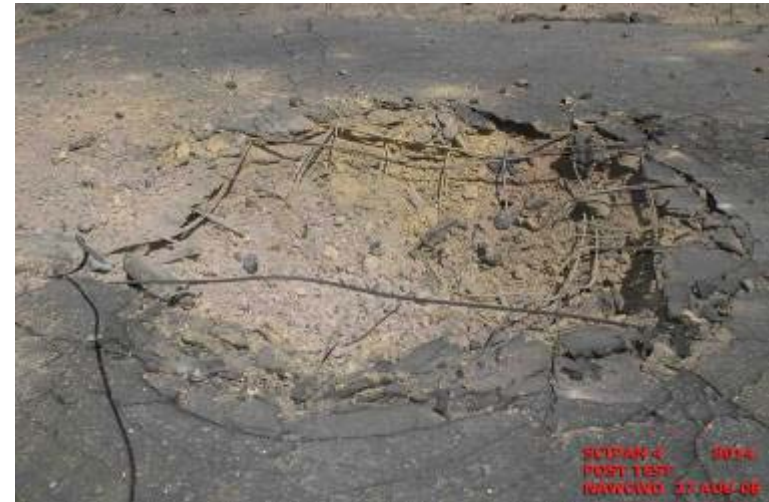
- Crater diameter varied between 2.5 and 3 meters
- Maximum depth of crater approximately 0.65 meters

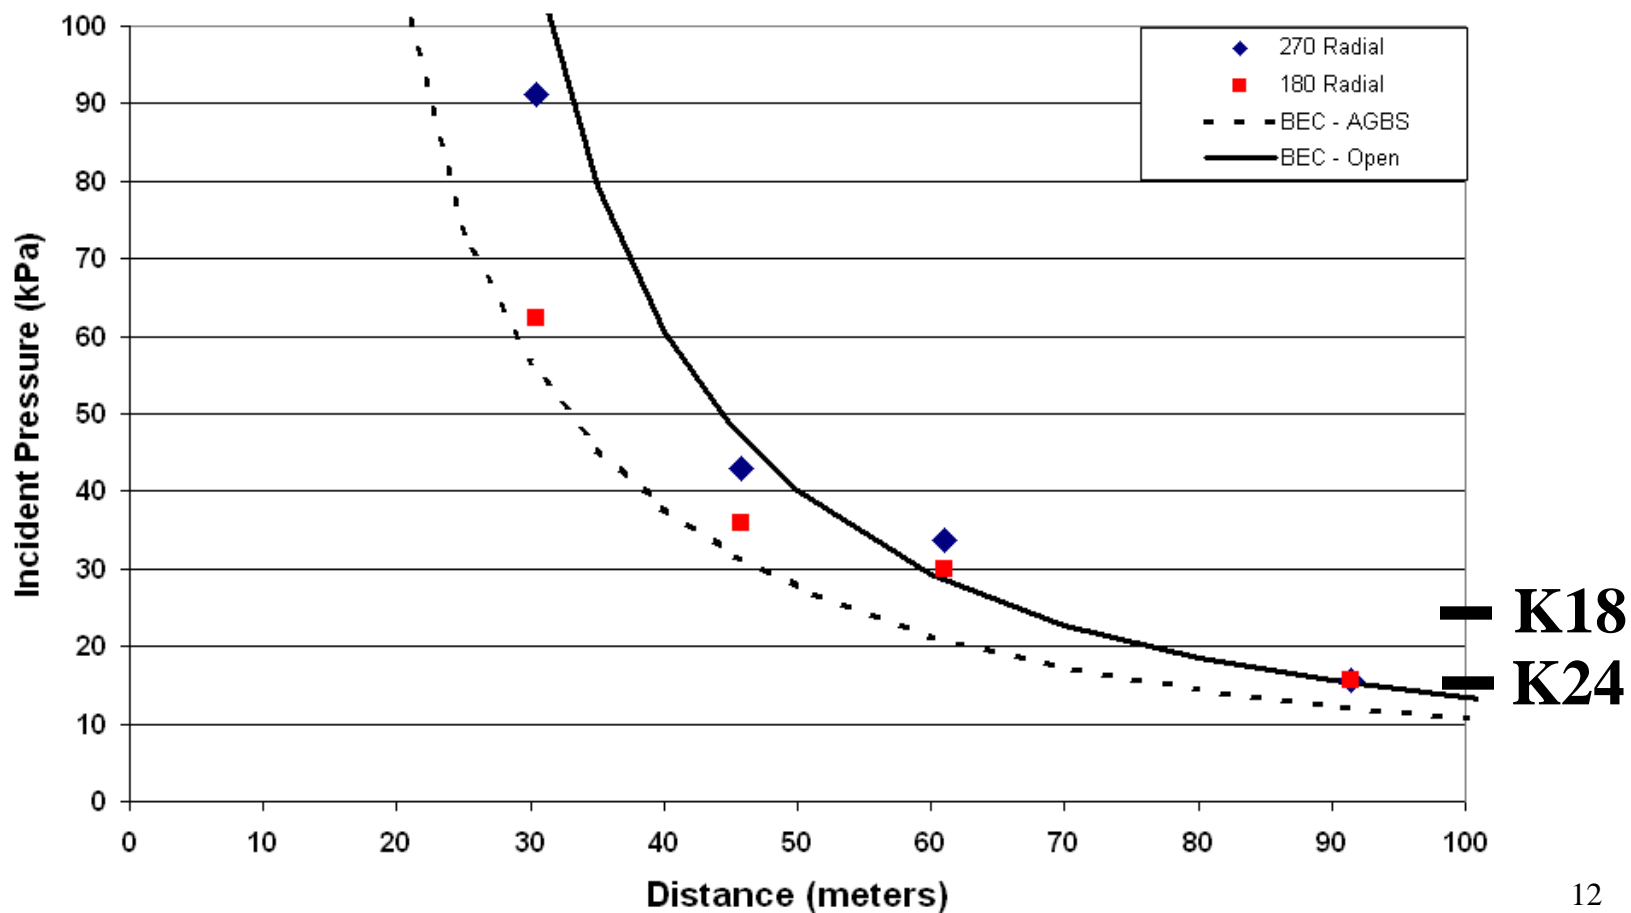
SciPan 4 Overpressure Comparison

Pressure Data Comparison

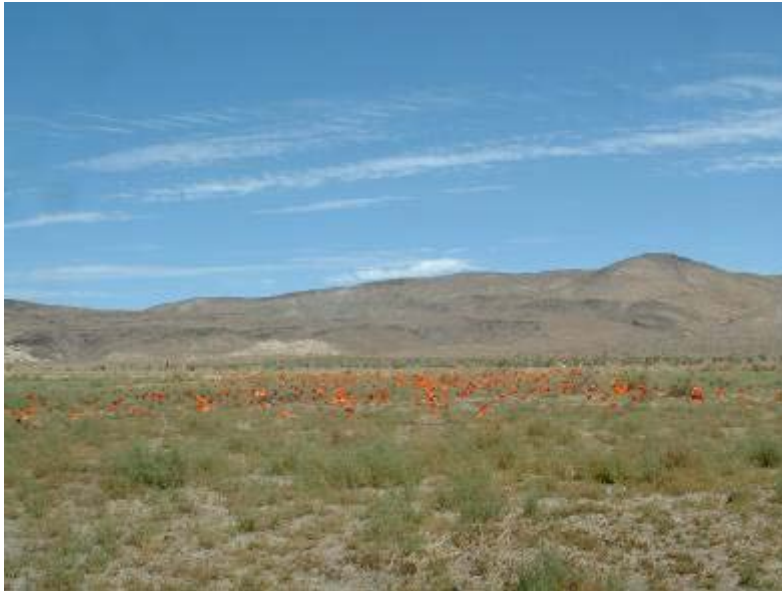
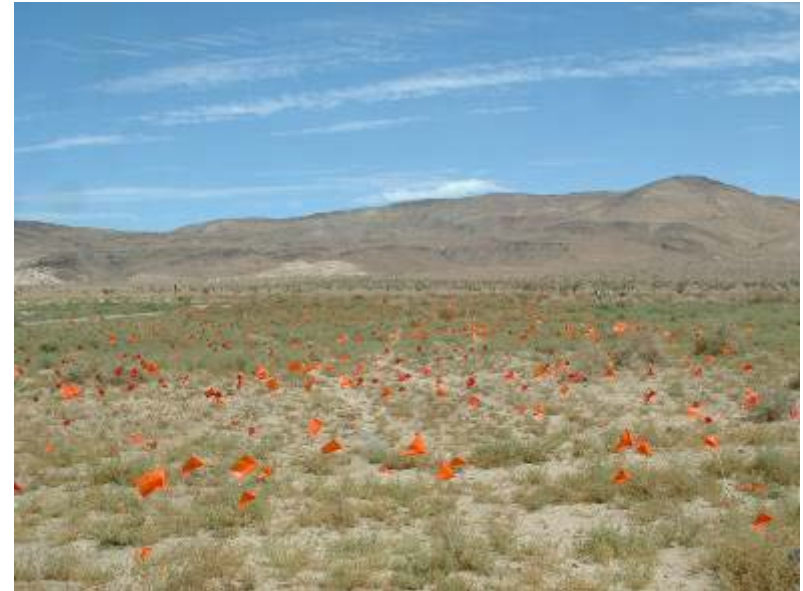
Debris Collection Process

The areas within +/- 10 degrees of the normals out to ~400 meters were **very** heavily saturated with debris

The decision was made to concentrate cataloging effort outside 300 meters (complete 360° clean-up) and off-normals inside 300 meters (everything but the normals)¹⁴

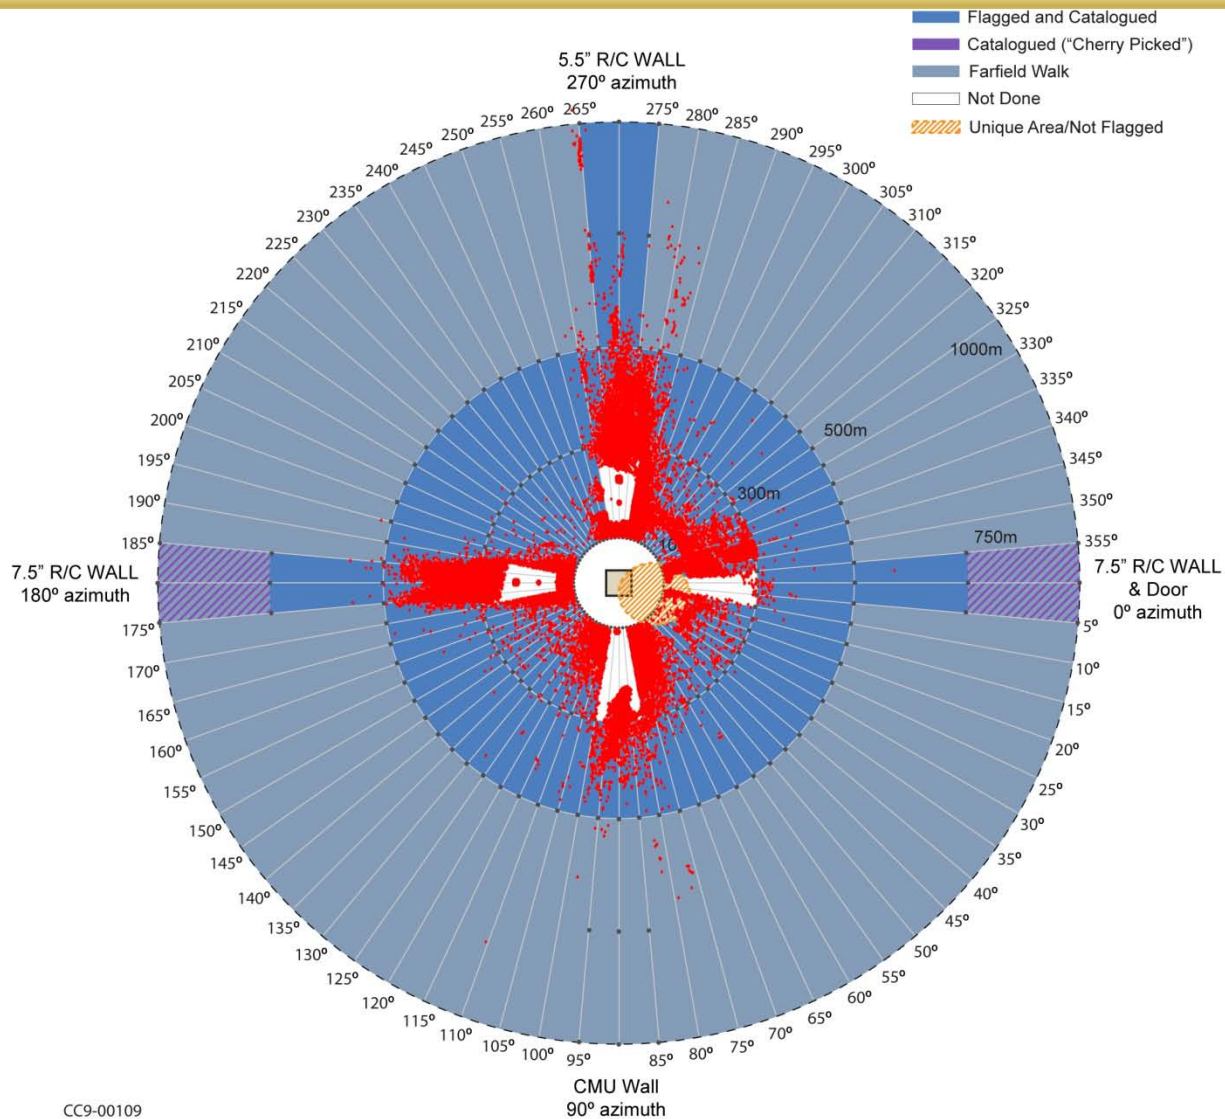
SciPan 4 Debris Scatter Plot

Farthest piece found at 1,018 meters

- The directionality of the wall debris pattern is quite apparent
- The high density area of $\pm 10^\circ$ out to 300 meters was not collected in the initial effort
- During DIRT 4.2, the area from 100 to 120 meters, $\pm 10^\circ$ of the normal was collected, as well as two square sections centered on the normals
- This was done on both the 5.5" R/C wall and the 7.5" R/C wall
- Having this information allows for interpolation of the areas not collected

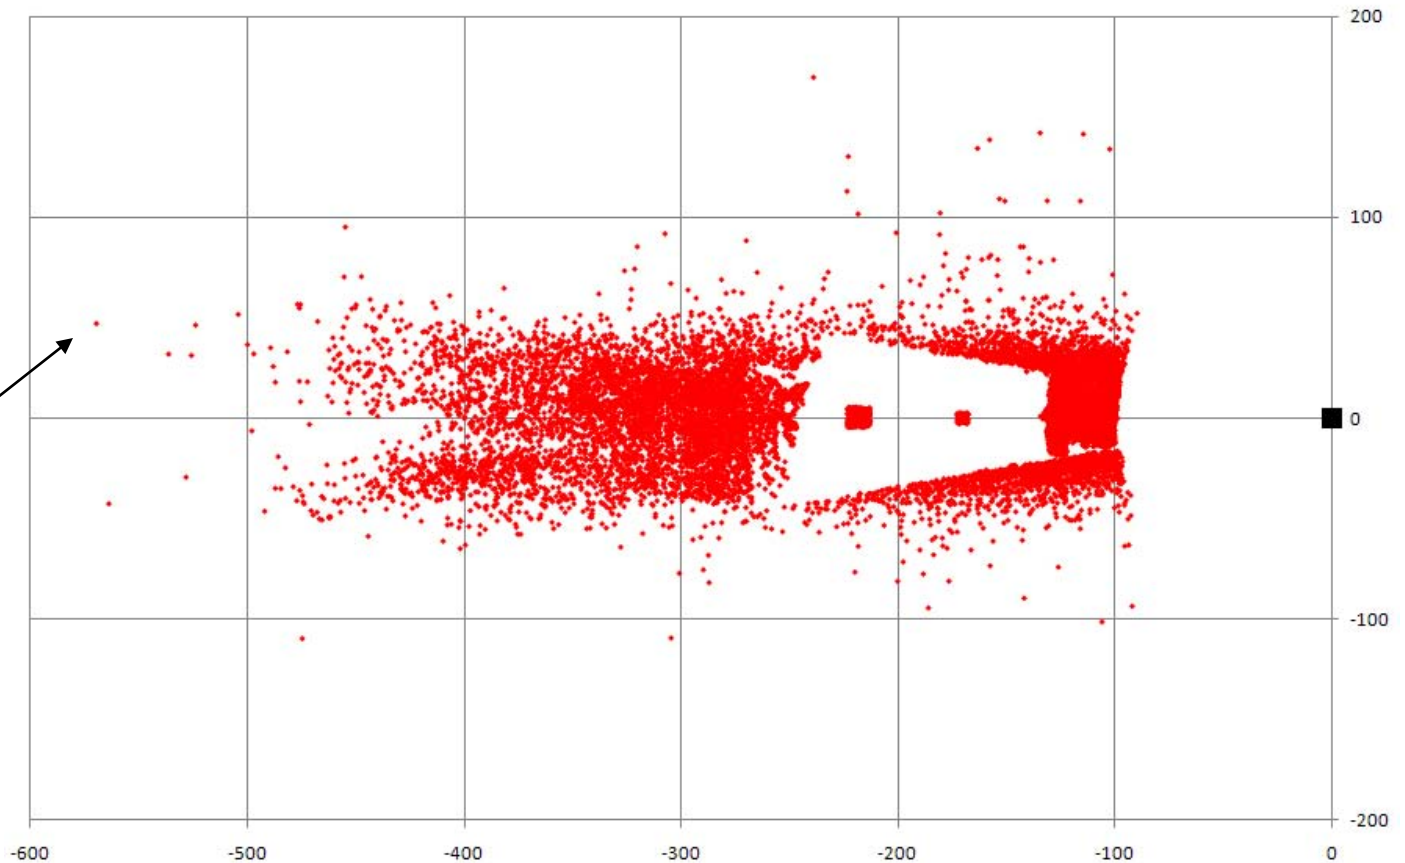
Debris Pattern: 7.5" Concrete Wall

Farthest piece
found at 572
meters
